2018 Update

Fuel Tank Advisory Committee (FTAC)

November 1, 2018

Navy and DOH Update on the Administrative Order on Consent (AOC) at the Red Hill Bulk Fuel Storage Facility

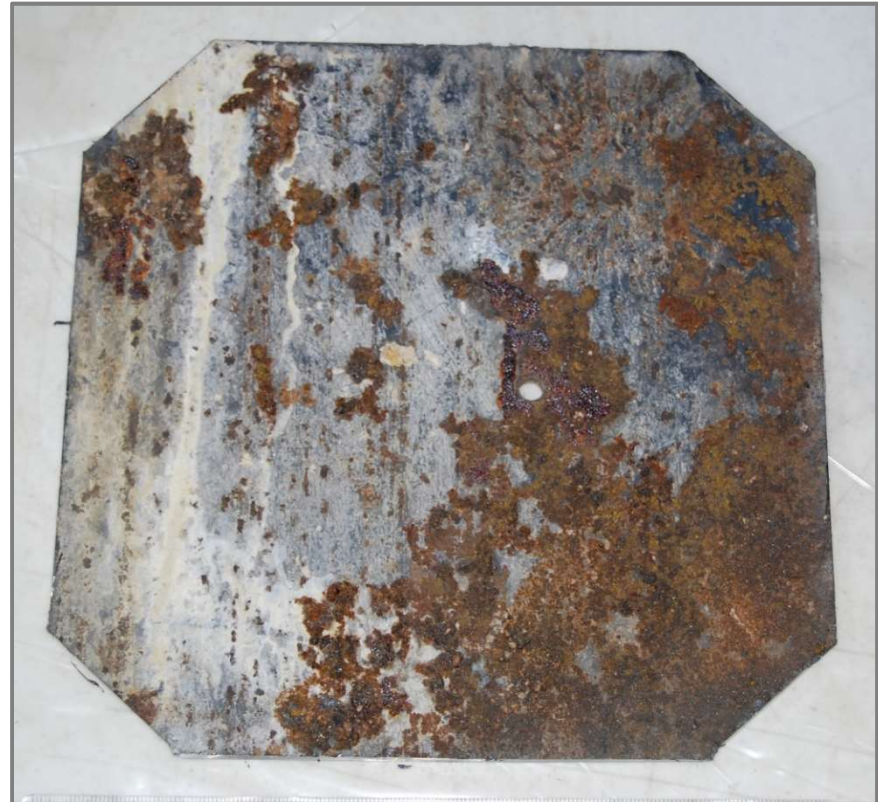
Coupon #1

- Screening scan indicates repair is necessary
- Prove-up scan indicates repair is necessary
- **Expect lab measurements to validate NDE measurements**

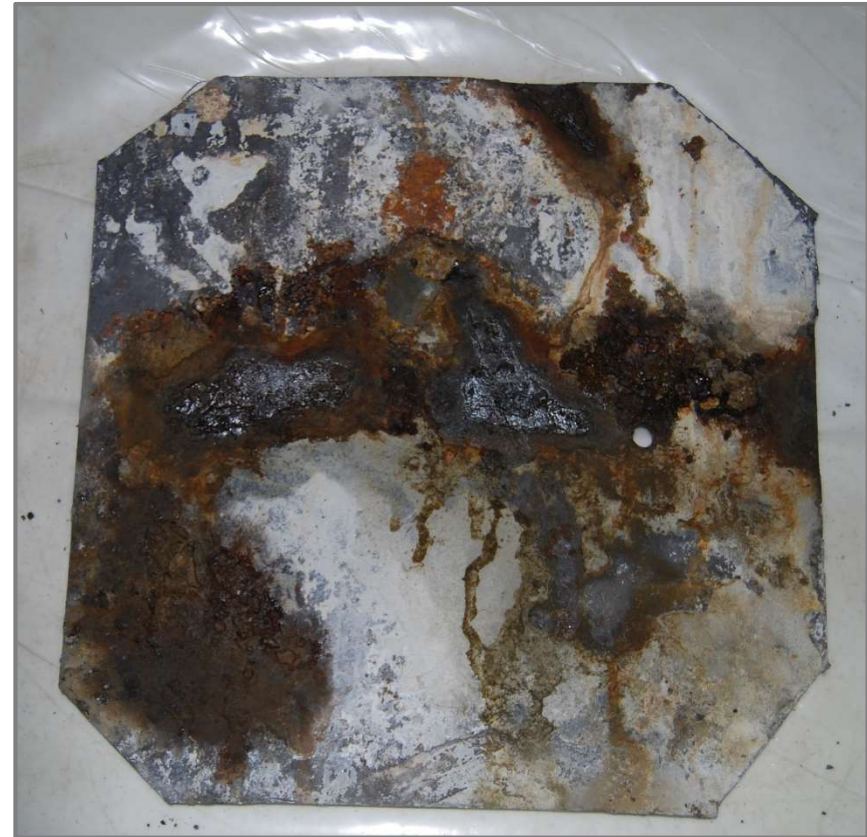
Coupon #2

- Screening scan indicates repair is necessary
- Prove-up scan indicates repair is necessary
- **Expect lab measurements to validate NDE measurements**

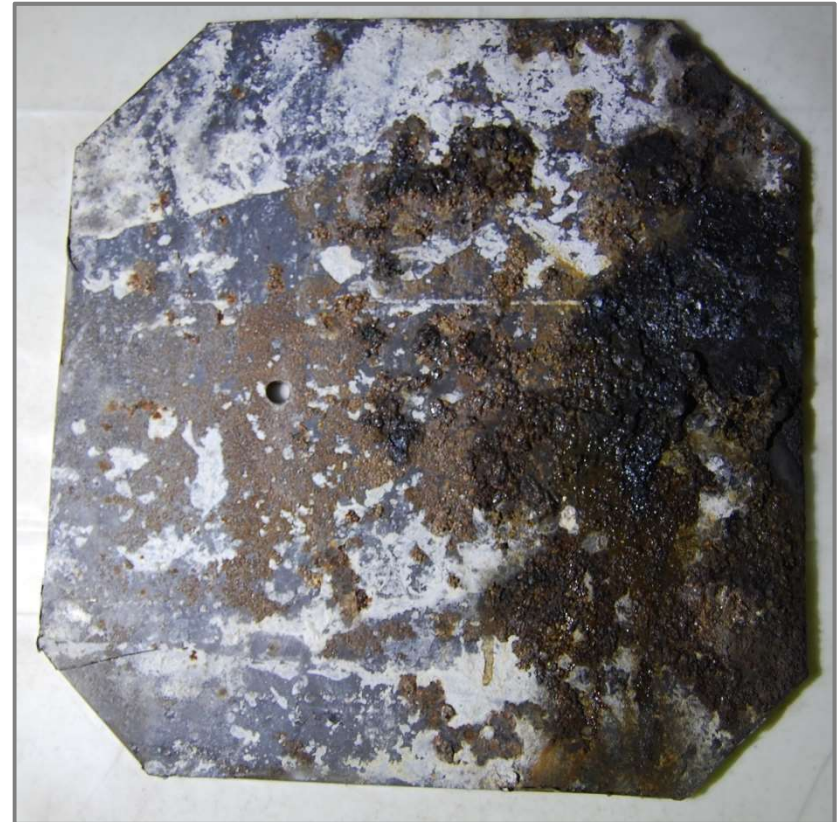
Coupon #3

- Screening scan indicates repair is necessary
- Prove-up scan indicates repair is unnecessary
- **Expect lab measurements to validate NDE measurements**

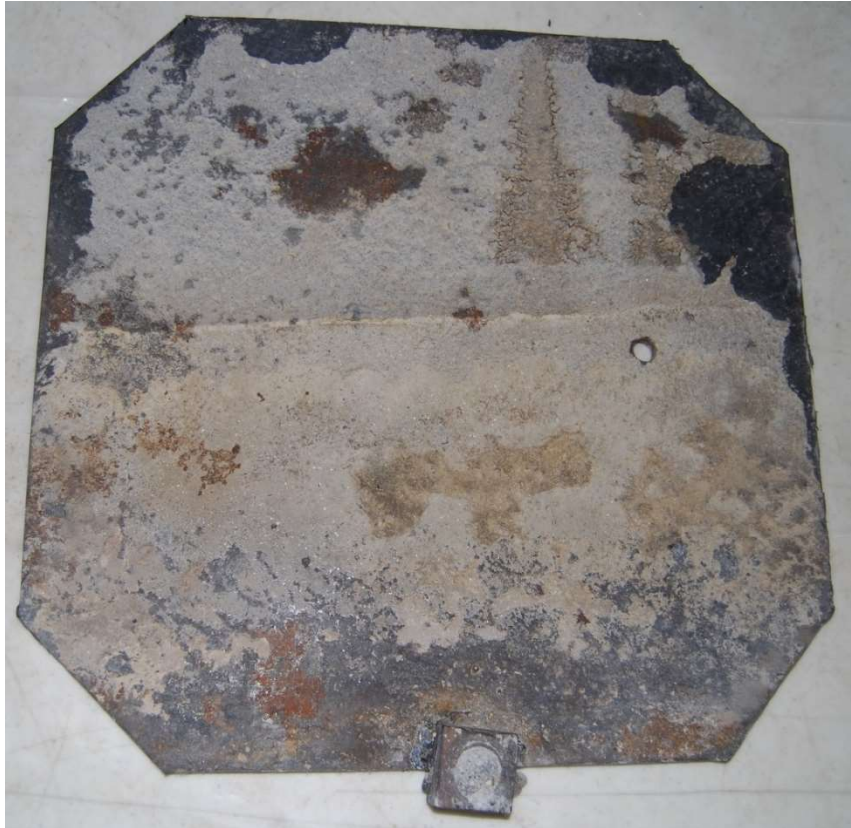
Coupon #5

- Screening scan indicates repair is necessary
- Prove-up scan indicates repair is necessary
- **Expect lab measurements to validate NDE measurements**

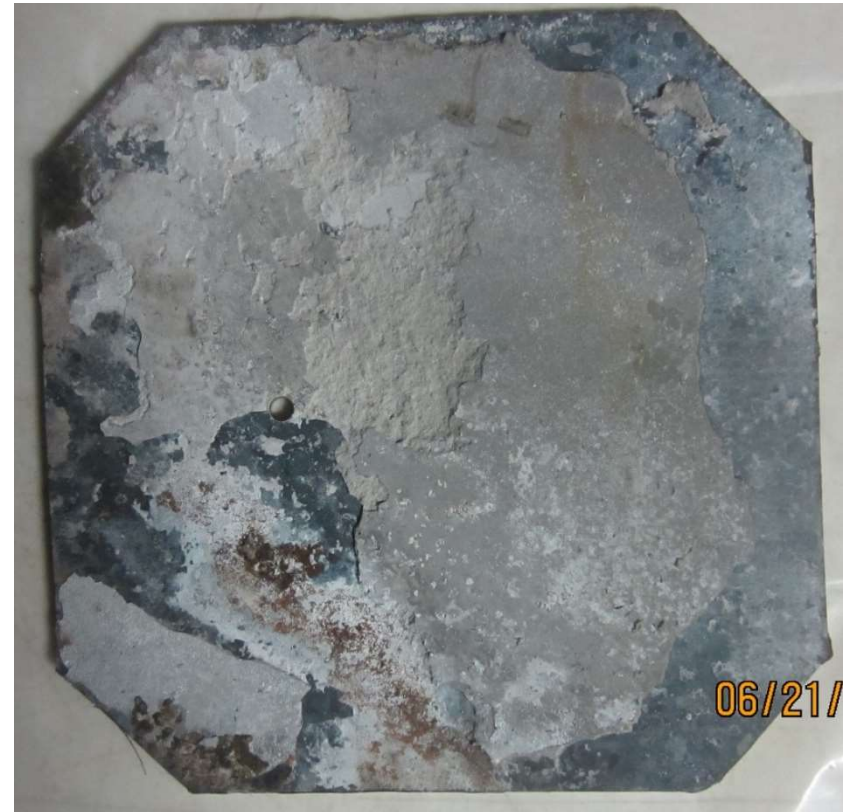
Coupon #6

- No Non Destructive Evaluation performed
- Control sample only

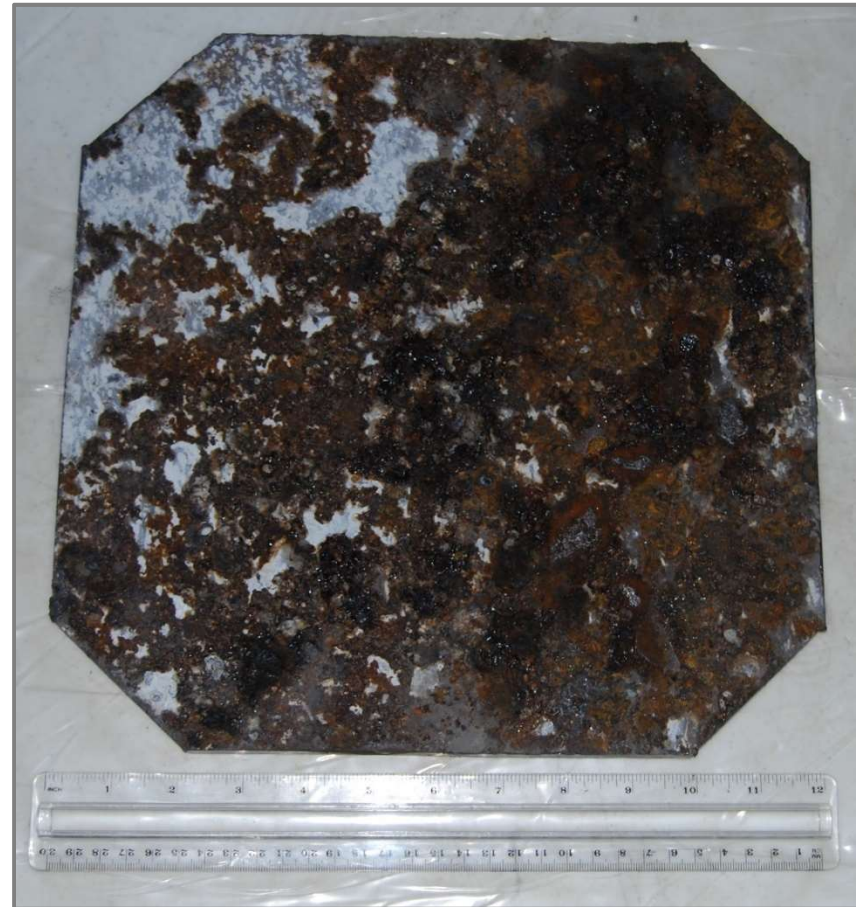
Coupon #7

- Screening scan indicates repair is necessary
- Prove-up scan indicates repair is necessary
- **Expect lab measurements to validate NDE measurements**

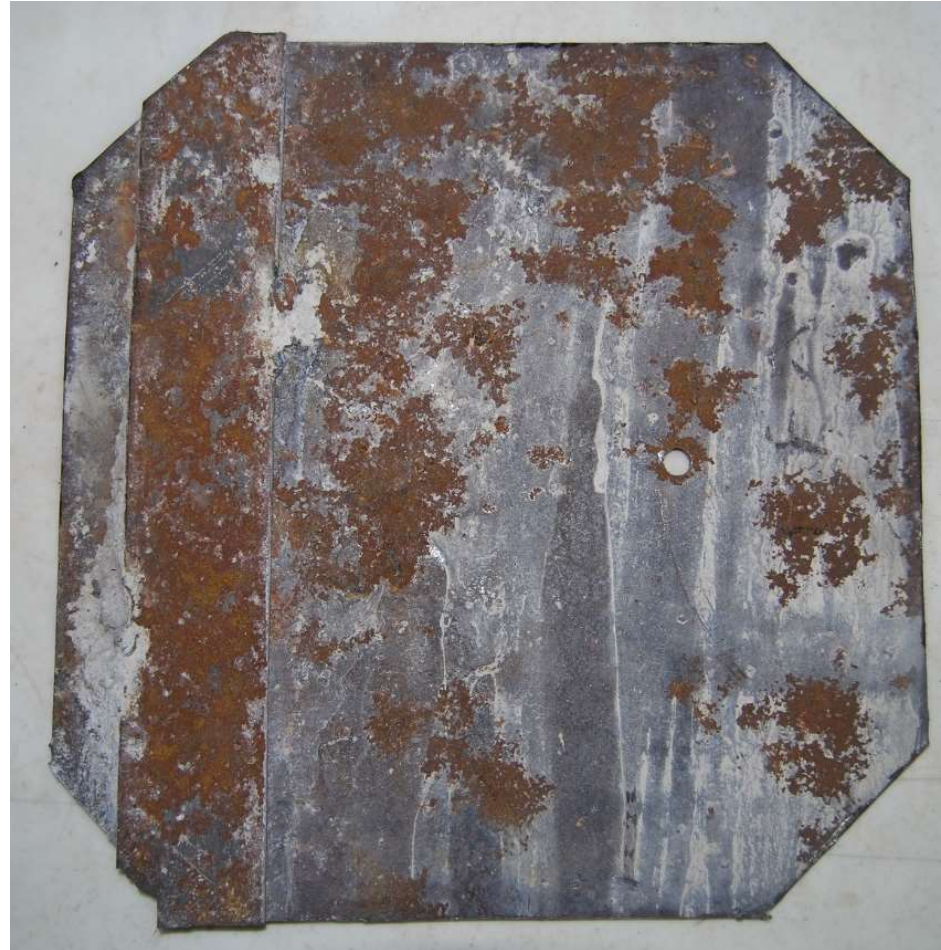
Coupon #8

- Screening scan indicates repair is necessary
- Prove-up scan indicates repair is unnecessary
- **Expect lab measurements to validate NDE measurements**

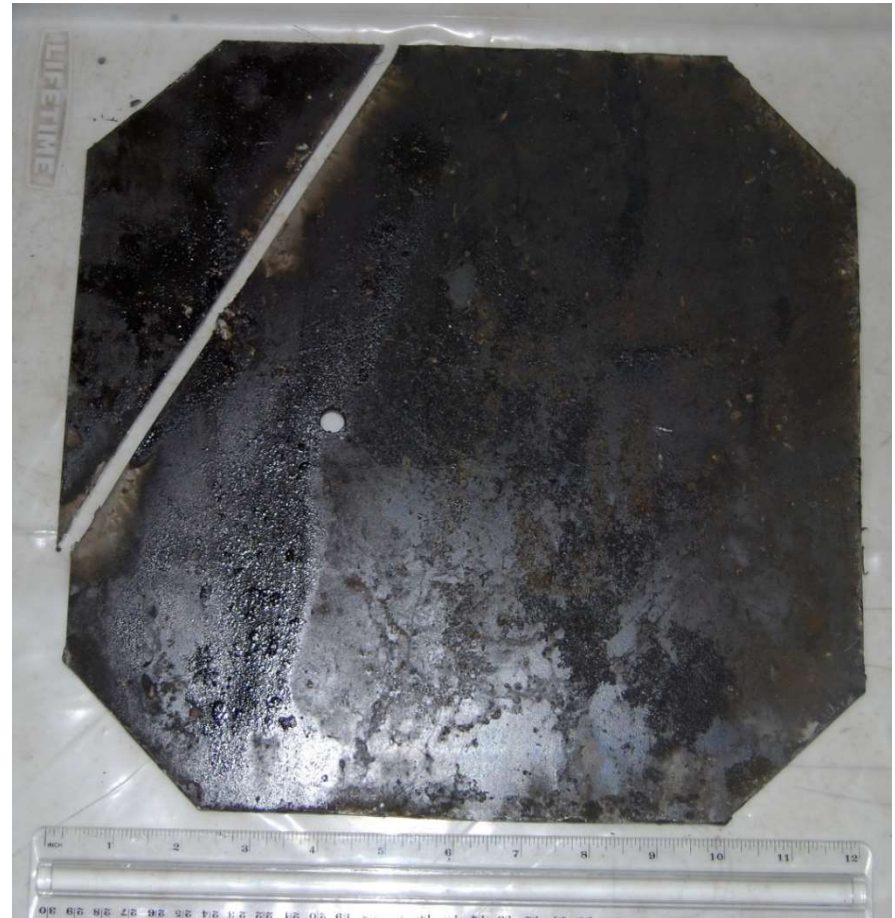
Coupon #10

- Screening scan indicates repair is unnecessary
- **Expect lab measurements to validate NDE measurements**

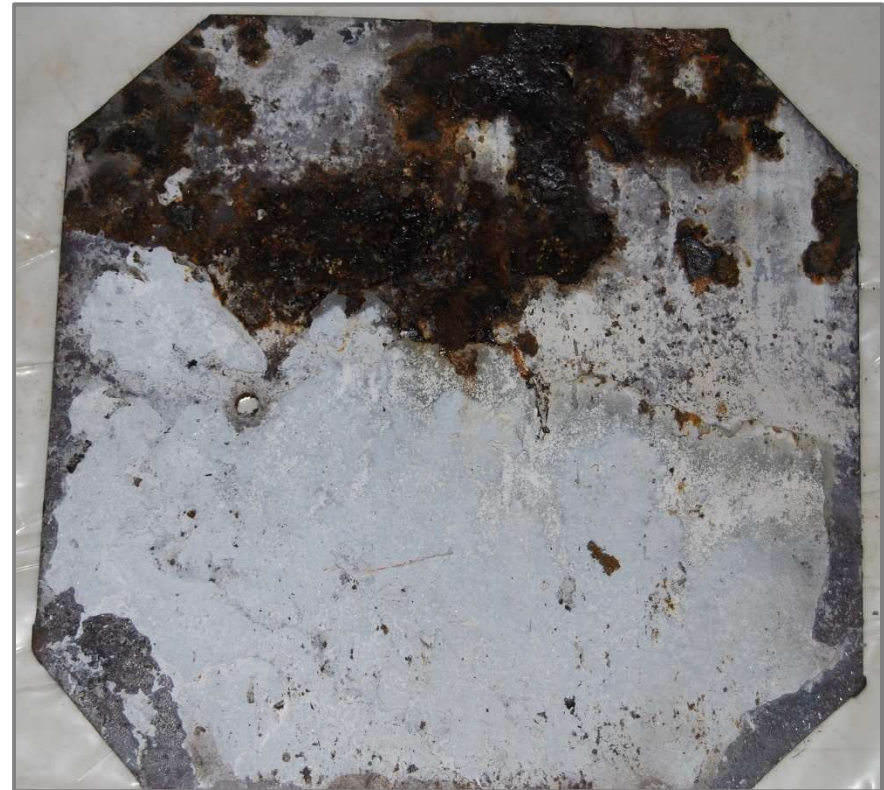
Coupon #A1

- Screening scan indicates repair is necessary
- Prove-up scan indicates repair is necessary
- **Expect lab measurements to validate NDE measurements**

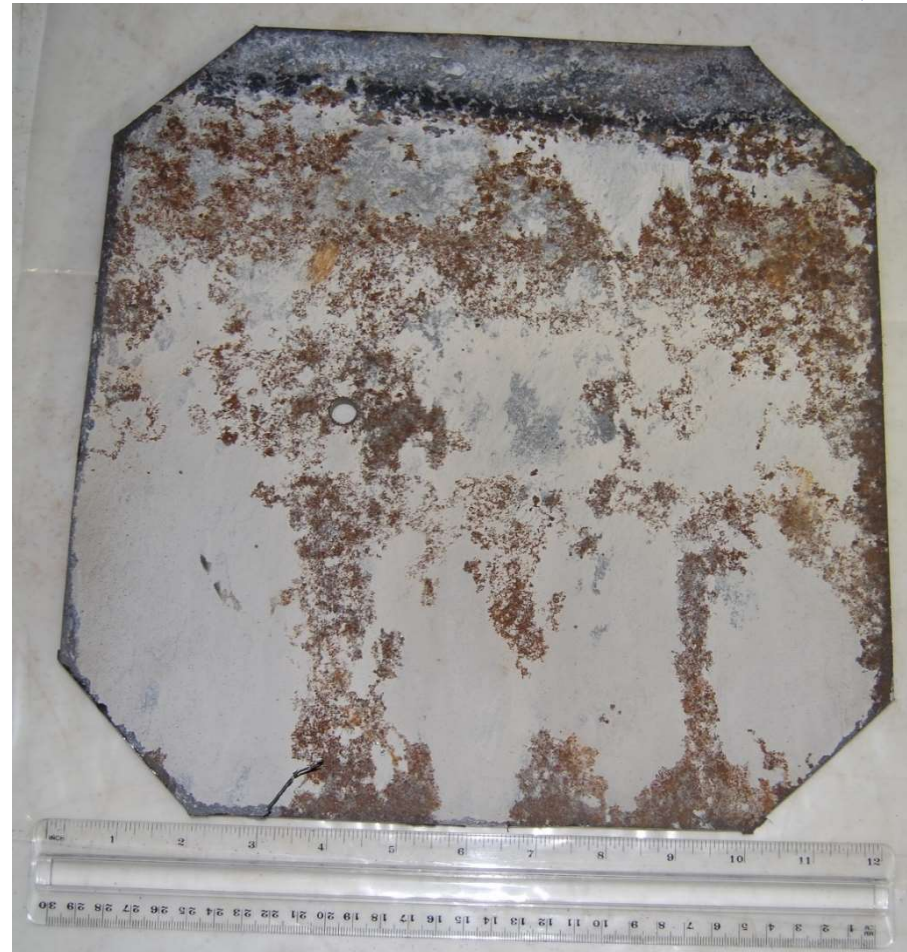
Coupon #A2

- Screening scan indicates repair is unnecessary
- **Expect lab measurements to validate NDE measurements**
